Subject: Tapoco Hydroelectric Project (FERC No. 2169) – License Compliance
Article 405 – Final Summary Report

Tapoco Project (FERC No. 2169)

**ARTICLE 405 – Monitoring Plan for the Cheoah River Bypass Reach
Minimum Flow and Ramping Rates**

FINAL SUMMARY REPORT

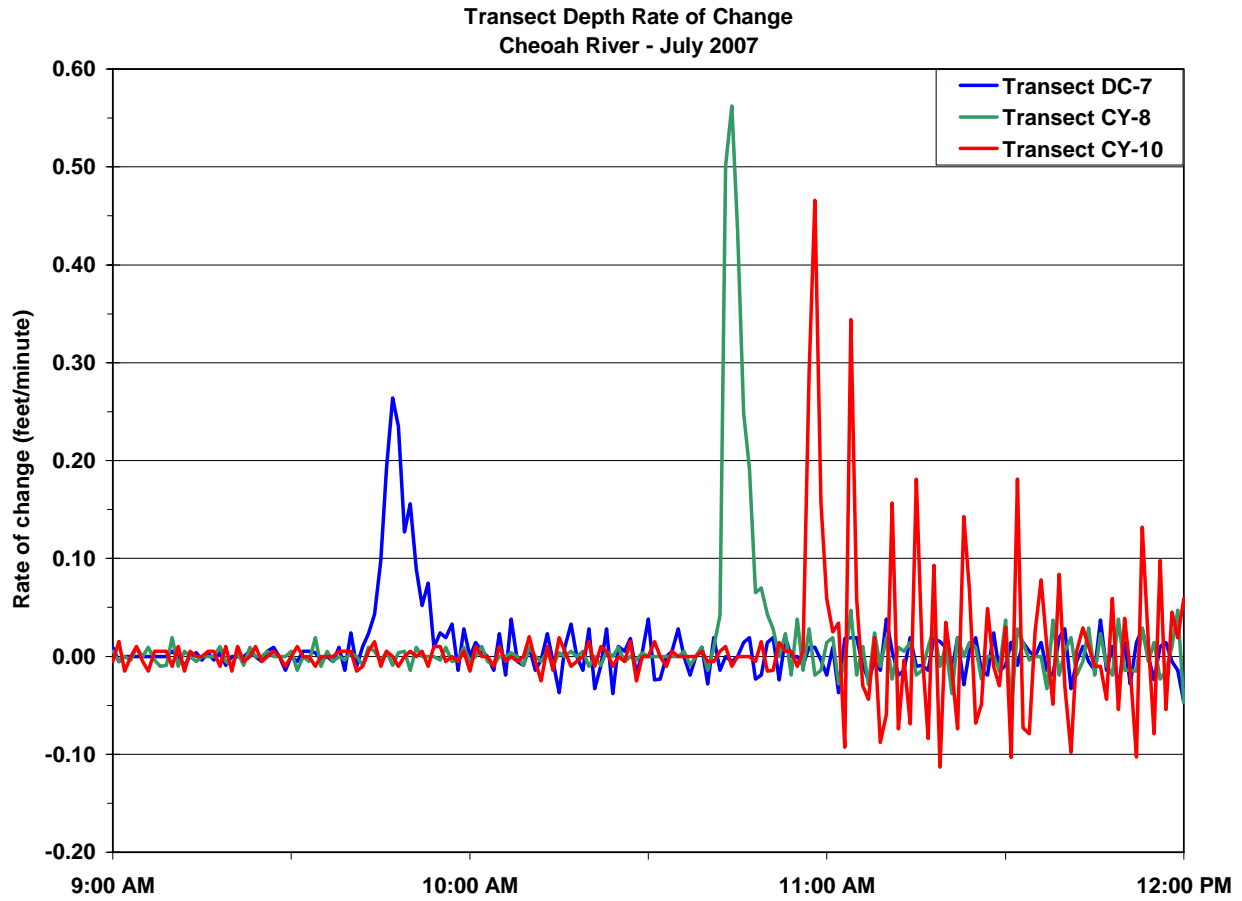
Figure 6. Rate of change in water depth (feet per minute) at instream flow transects in Cheoah River during arrival of scheduled high flow event on July 7, 2007.

Water level probes were deployed at transects DC7, CY8 and CY10 during July 2007 to measure water depths under base flows, ramping flows and high flows (Figure 5). Depths increased about 0.3 – 0.5 feet from base flow to the ramping flow over a period of at least two hours (Table 1). In contrast to this gradual rise, depths increased about 1.3 – 2.2 feet in roughly 20 minutes as flow increased from the ramping flow to the high flow. This rapid rise is evident when calculated as an instantaneous (one minute) rate of change in depth (Figure 6).

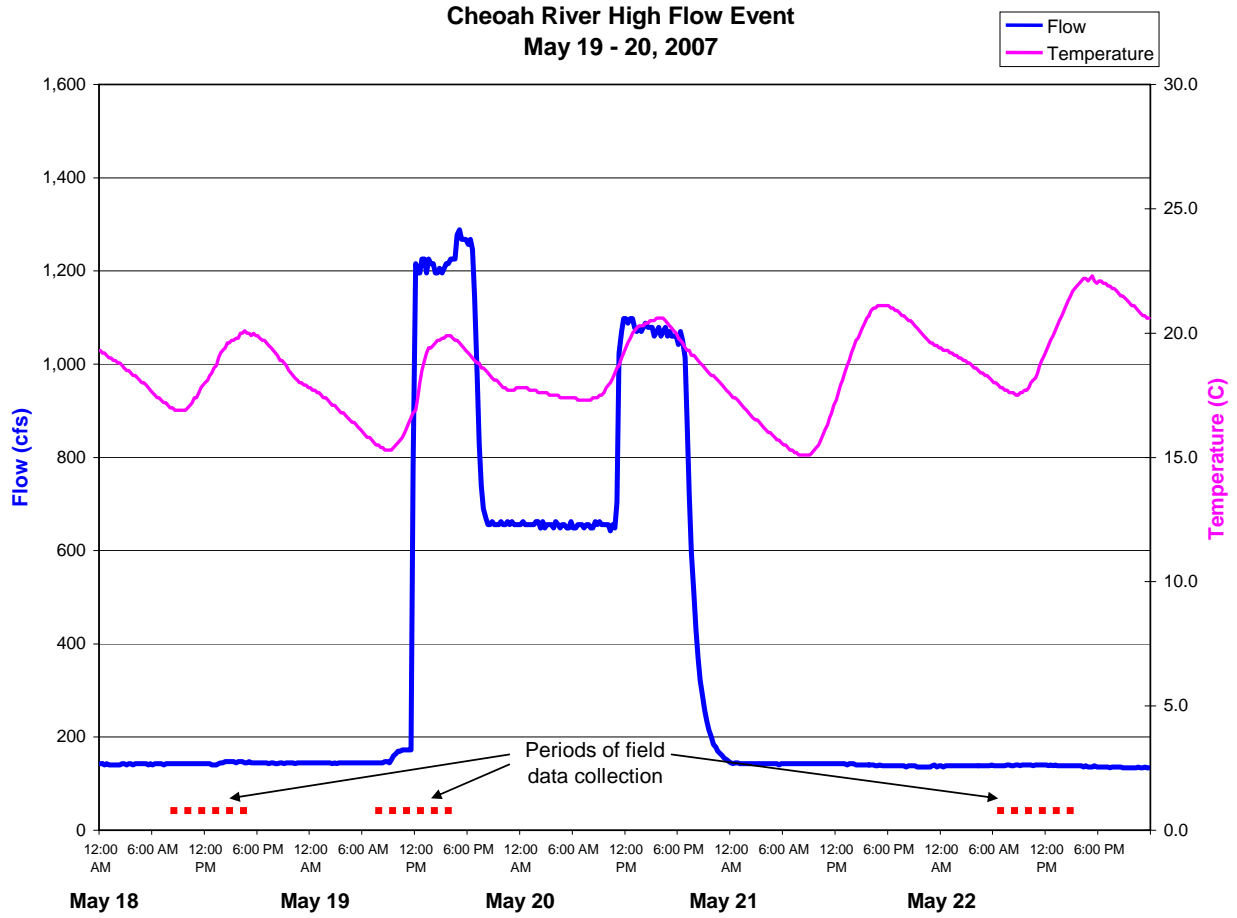
Figure 7. Instantaneous (15-minute) flow (cfs) and temperature (C) of Cheoah River during field data collections associated with May 2007 scheduled high flow event.

Flow and temperature conditions during field observations in May and July 2007 and May 2008 were typical of base flow and high flow events required by the License (Figures 7 through 9). The Resource Agencies observed and photo documented the changes in the river channel and aquatic resources under the various flow regimes. The Resource Agencies also measured the size and shapes of fish nests of some common species (chub, sunfish/smallmouth bass), sampled using drift nets, and collected flow and level logger data.

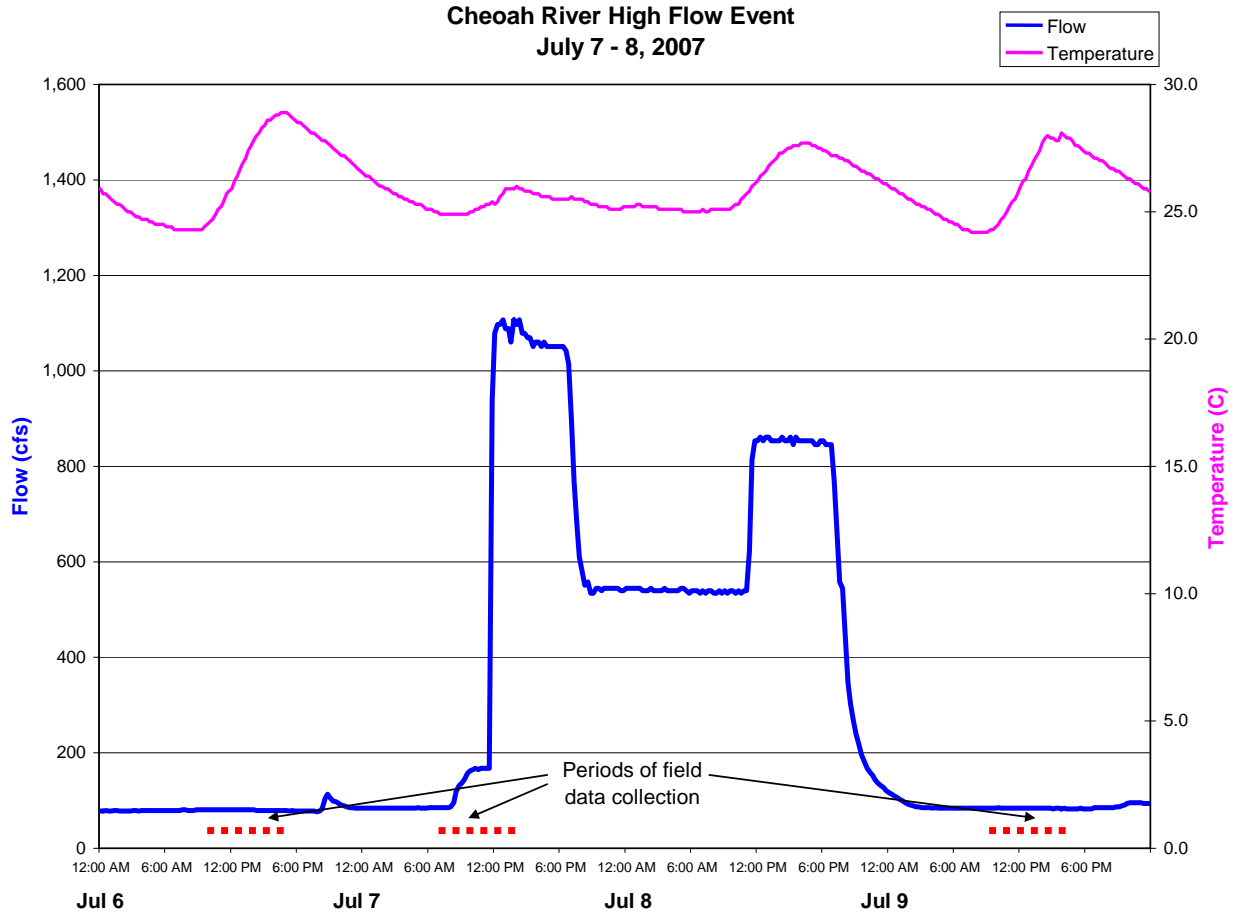
Figure 8. Instantaneous (15-minute) flow (cfs) and temperature (C) of Cheoah River during field data collections associated with July 2007 scheduled high flow event.

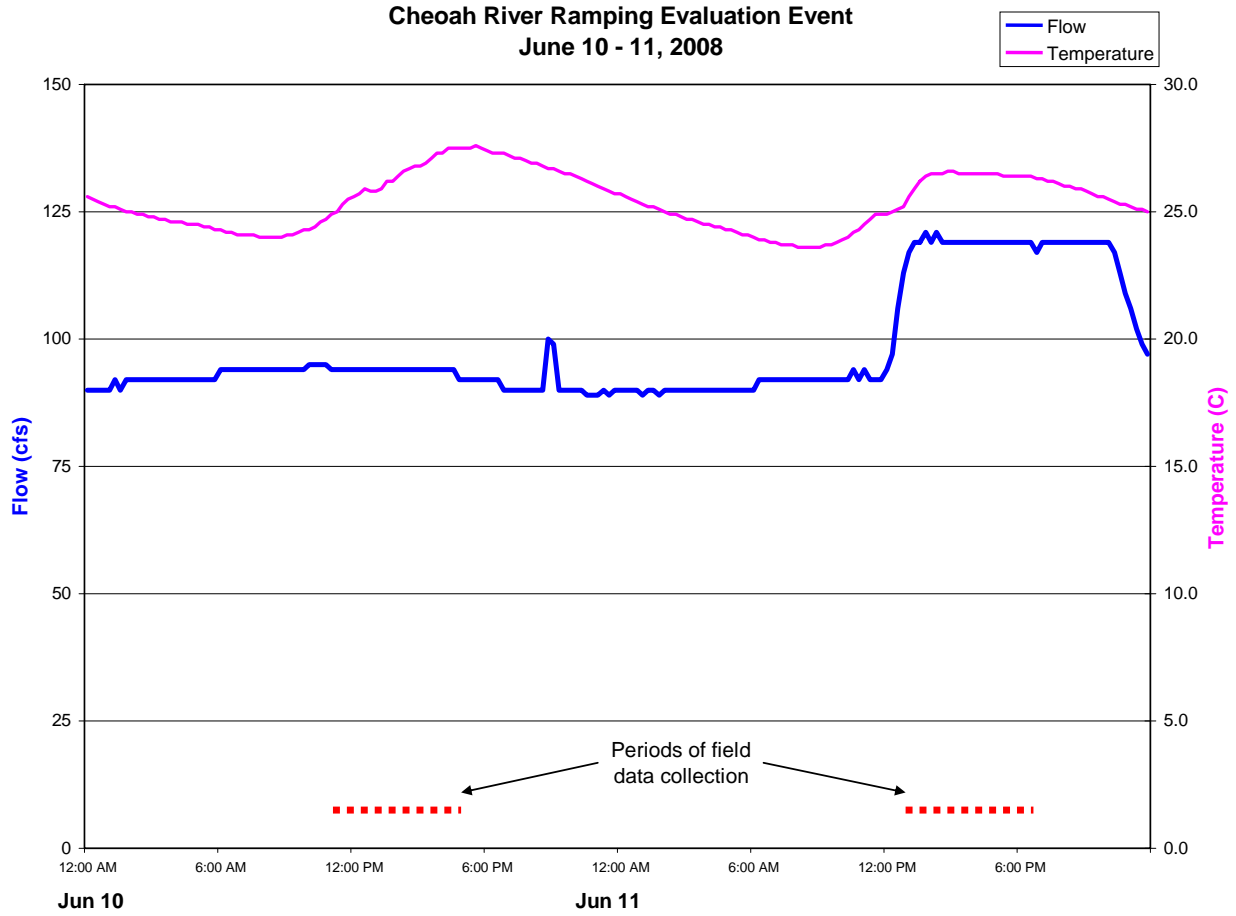
Figure 10. Instantaneous (15-minute) flow (cfs) and temperature (C) of Cheoah River during field data collections associated with June 2008 ramping release.

In June 2008, field efforts were designed to measure differences in stream conditions between the base flow of 60 cfs and the ramping flow of 100 cfs required prior to a high flow event (Figure 10). To facilitate this evaluation, APGI temporarily re-positioned the mini-gates from the normal aquatic flow of 60 cfs to 100 cfs for one day.

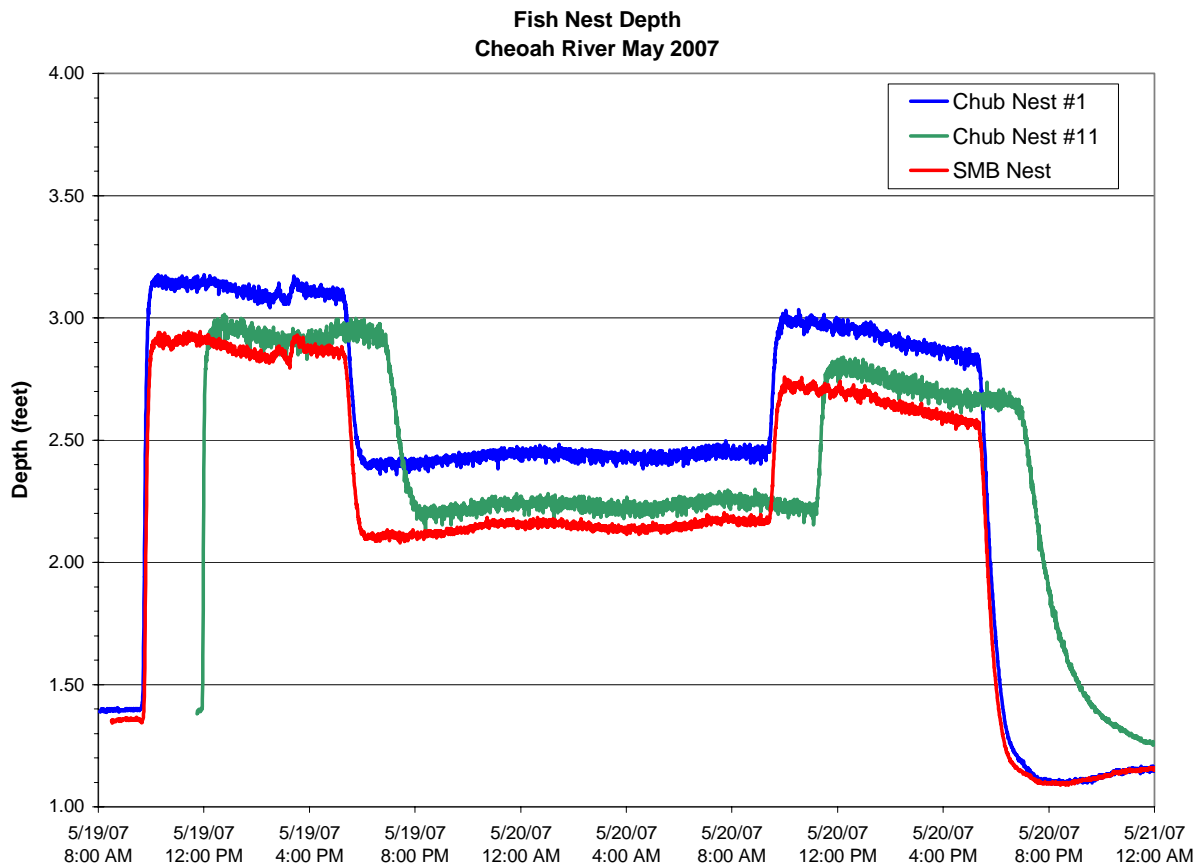
Figure 11. Water depth (feet) over fish nests in Cheoah River during high flow event in May 2007.

Level loggers placed at two chub nests and one smallmouth bass nest during May 2007 indicated a rapid rise in depth (Figure 11) of a similar magnitude to that observed at the instream flow transects. The rate of change in depth (Figure 12) was also similar between the fish nests and the transects.

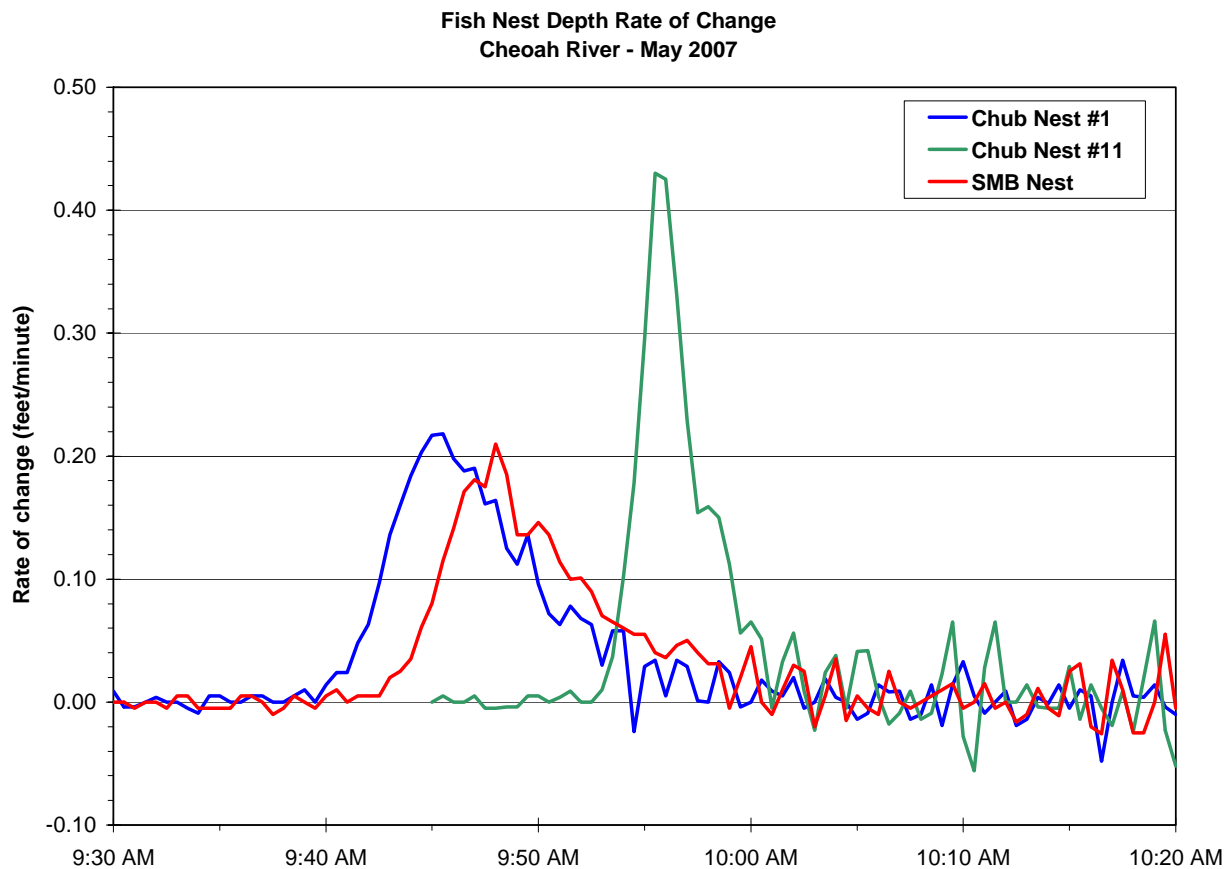
Figure 12. Rate of change in water depth (feet per minute) over fish nests in Cheoah River during arrival of high flow event on May 19, 2007. Note: Data for chub nest #11 were shifted 3 hours earlier than actual time in order to fit on graph.

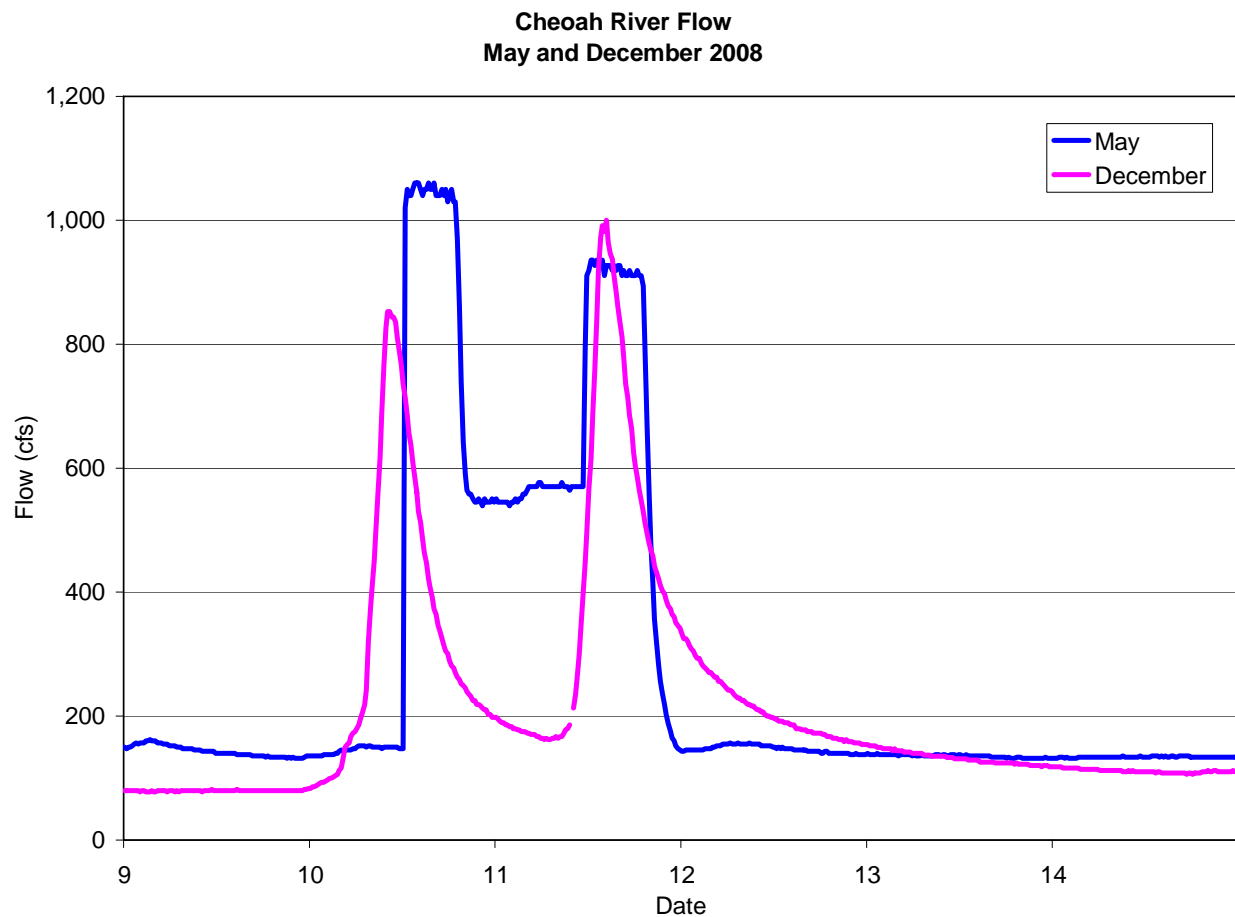
Figure 13. Instantaneous (15-minute) flow of Cheoah River during 2008 comparing the hydrograph shape of a regulated high flow event (May) and a similar magnitude natural high flow event (December).

While the changes in magnitude (e.g., depth) of the HFEs are fairly large, more important may be the rate at which those changes in depth and velocity occur. The rapid changes in hydraulic conditions are accompanied by an initial flush of turbidity by suspended sediments and debris. Shaping the high flow events in a more natural way could further reduce any potential impacts on the aquatic and riparian resources of the Cheoah River (Figure 13).
